# HAZARD ALERT

## Electrical and Work Organization Hazards Cause Injuries To a USW Member

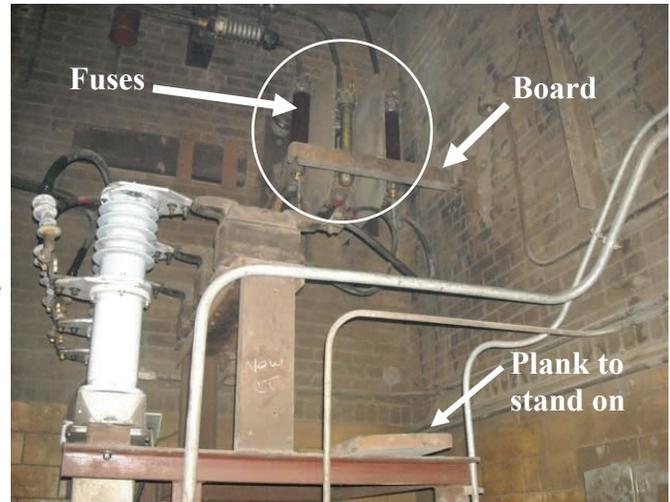
A worker in the maintenance department received a severe electrical shock and suffered critical burns when he was directed by a supervisor to, “put up fuses on the board” of a 13,200-volt fuse block assembly. The worker was a mechanic and not trained or experienced for work as an electrician. The 400-amp fuses, which had a history of blowing, are part of the main electrical power supply located in an unlocked electrical vault.

The maintenance department had been downsized and “multi-craft” job combinations created additional workplace hazards. The facility did not have a means to isolate the main electrical incoming power upstream from the vault. Electrical PPE, working live line tools, proper training and procedures were not provided for employees who performed servicing and maintenance in the high voltage electrical vaults.

- Install electrical equipment to isolate the main incoming electrical power to eliminate the exposure of working on or around energized parts. Employers must not rely on the power company always being available for power isolation.

- Increase maintenance staffing to ensure “qualified” employees are available to perform electrical work and cover any employee absences.
- Provide adequate training to hourly and salary personnel on Electrical Safety-Related-Work-Practices and NFPA 70E—Standard for Electrical Safety in the Workplace. The training must also cover employees job-related assignments, including their own limitations, such as: the maximum allowable approach distances to energized parts, familiarity with the proper PPE and shielding materials, proper use of test equipment, methods to distinguish energized parts from other parts of electrical equipment, etc.

- Perform a Shock and Arc Flash Hazard Analysis and use electrical PPE per NFPA 70E Hazard/Risk Categories.
- Provide and maintain the proper electrical tools for the job-related tasks.

- Provide and maintain the proper electrical PPE for the specific parts of the body to be protected and for the work being performed, such as pulling and replacing power fuses and substation voltage testing. (This work should have been assessed by the employer as Hazard/Risk Category 4 per NFPA 70E).
